# Manhole Inspection Summary

Manhole # S33EE1059MH

Record Plat: **33EE1** Node: **059** Status: **New Manhole (Not in GIS)** Insp Date: **9/8/08 9:53 AM**

**Location** Address: **3703 CHARLES ST**

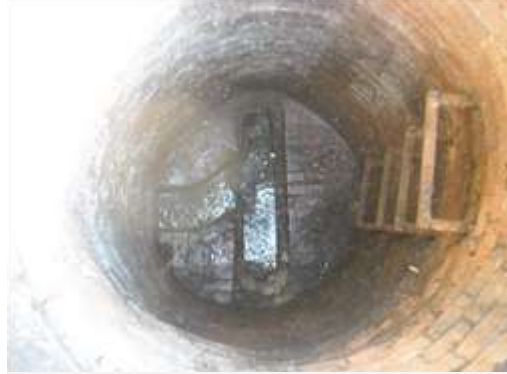
Top View

Evidence of surcharge - Bench debris.  
Channel debris.

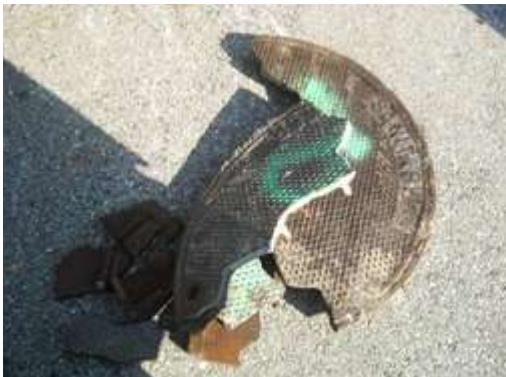
Broken lid

Comments **BROKE AND REPLACED CRACKED COVER TO COMPLETE INSPECTION.**

Had to break the lid to gain access to the MH.

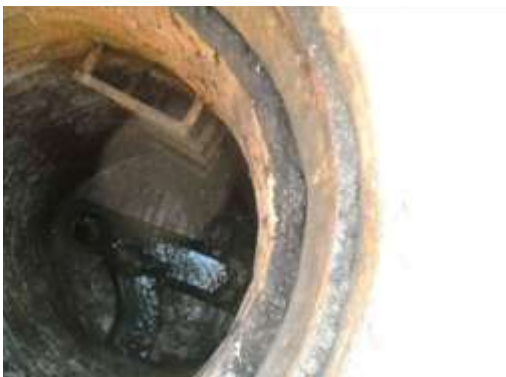
Defect

Condition: ☐ Sound ☐ Cracked ☐ Root Intrusion ☐ Loose Brick ☒ **Deteriorated**

Infiltration: ☐ None ☒ **Joint** ☐ Cracks ☒ **Mortar** ☐ Roots ☐ Wall

Infiltration: ☐ None ☐ Joint ☐ Cracks ☒ **Mortar** ☐ Roots ☒ **Wall**

Frame leaks. Frame offset. Corbel deterioration and infiltration. Barrel infiltration.

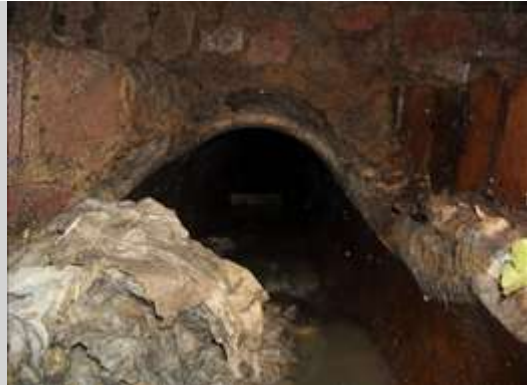
### 8 in. Circular Gravity Sewer Pipe Out @ 12 O'Clock

Channel debris.

Deposits: ☐ None ☐ **Mud** ☐ Sludge ☒ **Debris** ☐ Grease

Silt Depth: **0** (in.) Deposits Extent: **Heavy**

Infiltration: **Evidence** Pipe Seal Cond: **Cracked**

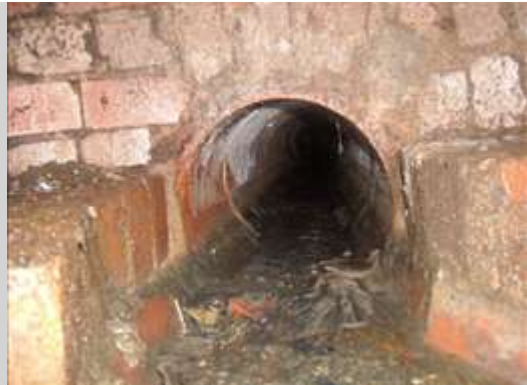
8 in. Circular Gravity Sewer

Deposits: ☐ None ☒ **Mud** ☐ Sludge ☒ **Debris** ☒ **Grease**

Silt Depth: **1.5** (in.)
